No. 10/72

Service sheet

B25/B50 ENGINES

CONTACT BREAKER

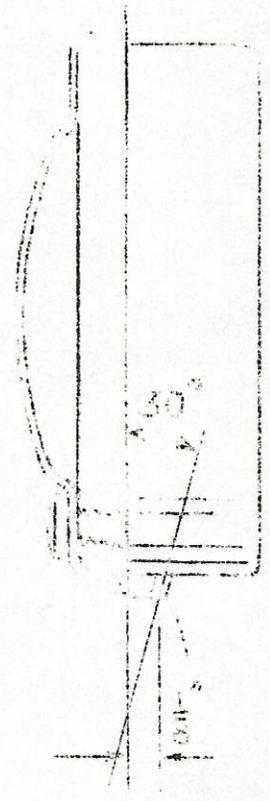
Lack of attention to the contact breaker and automatic advance-and-retard timing mechanism, can lead to the corrosion of these items, due to the accumulation of condensation.

In this event, the timing mechanism may be the cause of erratic running and in extreme cases may become completely ineffective.

To prevent this accumulation, drill a 1/16" dia. hole in the base of the contact breaker housing, in accordance with the details given in the illustration, thus providing a means of drainage for the condensation.
