Service Bulletin #200

December 3, 1965

BATTERIES AND FUSE IN 1966 A65 LIGHTNING, THUNDERBOLT AND ROYAL STAR 500 MODELS: MUST BE INSPECTED & SERVICED AS FOLLOWS:

1966 A50 and A65 Models.

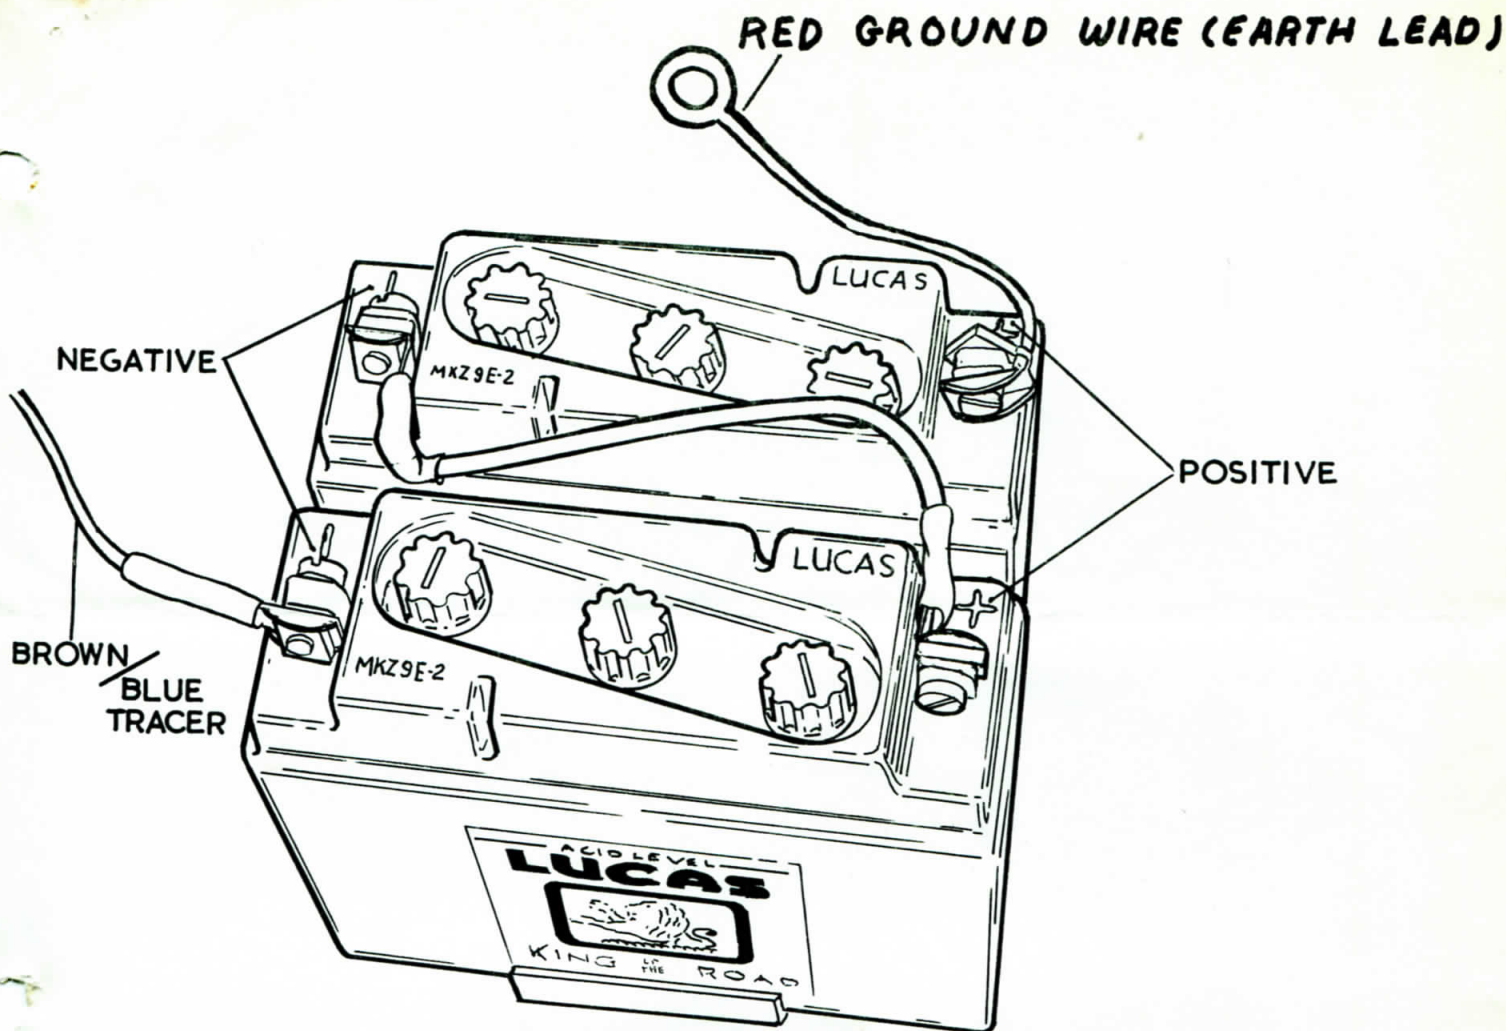
The first deliveries of 1966 battery ignition models are fitted with fuses in the red earth (ground) wire from the positive battery terminal. Experience has shown that failure of this fuse can lead to mechanical trouble should the engine continue to run while the battery is in open circuit.

In addition to this replacement it is important to note that a few machines have left the factory with the uncharged batteries fitted to the machine the wrong way round. Dealers must note the correct position of each

To safeguard against this problem, the red fused lead must be replaced by a ground wire without a fuse before machines are sold.

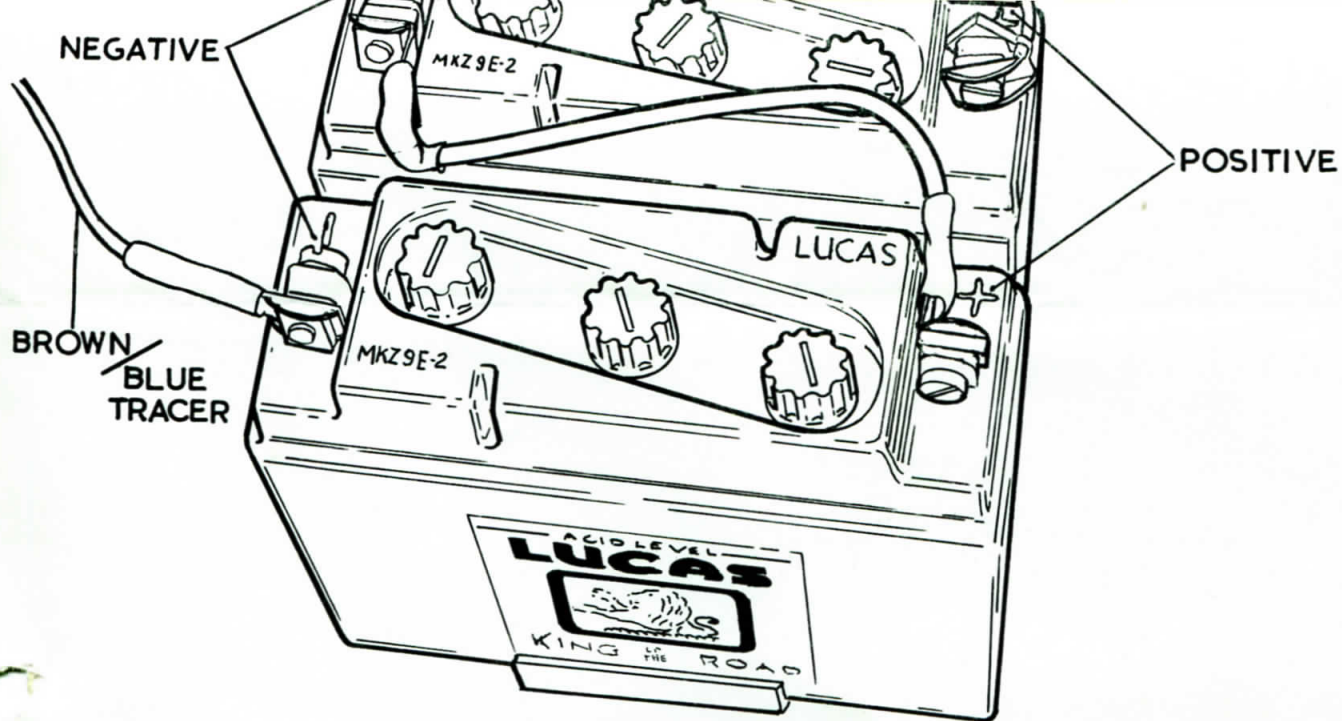
The first deliveries of 1966 battery ignition models are fitted with fuses in the red earth (ground) wire from the positive battery terminal. Experience has shown that failure of this fuse can lead to mechanical trouble should the engine continue to run while the battery is in open circuit.

In addition to this replacement it is important to note that a few machines have left the factory with the uncharged batteries fitted to the machine the wrong way round. Dealers must note the correct position of each battery and the wires connecting the batteries as shown in the above illustration and should not simply replace the battery pack in its original position following filling and initial charge.

To safeguard against this problem, the red fused lead must be replaced by a ground wire without a fuse before machines are sold.

Caution: Be sure the battery connecting wires are in place and do not touch or rub against the battery carrier bracket.
