SERVICE BULLETIN #23-69

May 6, 1969

SUBJECT: Oil Leak at Gearbox Sprocket, Model A75 Rocket 3

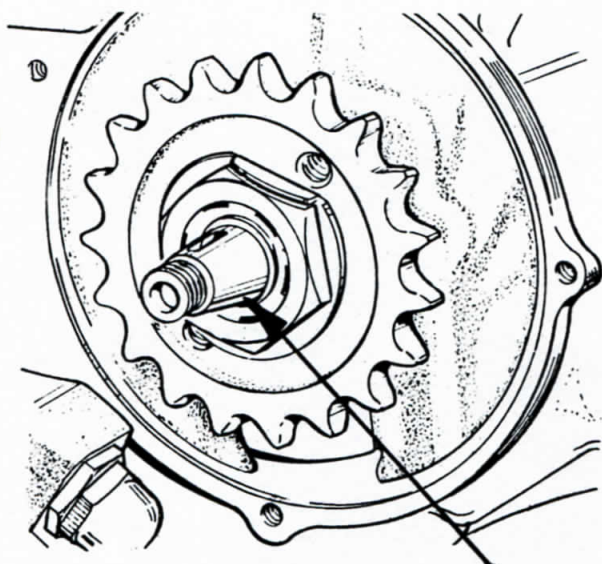
This oil seal, Part No. 57-1956 will prevent gearbox oil from seeping out along the gearbox mainshaft and the high gear bush as shown in the illustrations below:

Illustration showing area of possible oil leakage at gearbox mainshaft high gear bush.

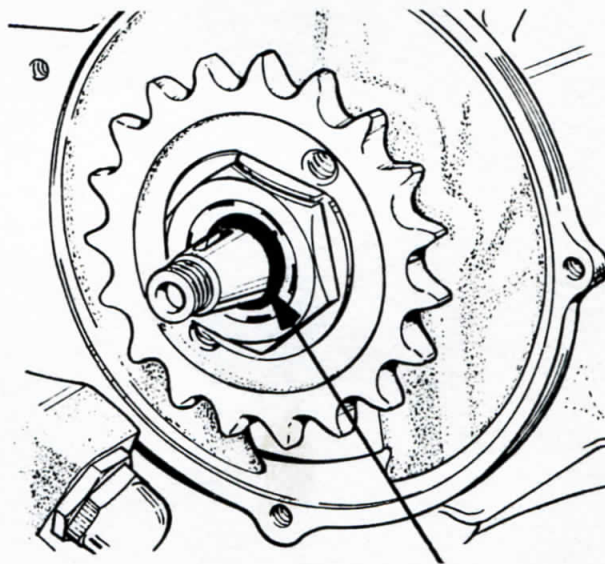
Illustration showing oil seal Part No. 57-1956 fitted on gearbox mainshaft.

An oil seal has been added at the gearbox mainshaft between the end of the high speed gear and the clutch hub.
