## DEALER PARTS and SERVICE BULLETIN

No. 99 17 DEC 1963

FITTING OF OIL UNION GASKET ALL B40 AND "C" SERIES MODELS

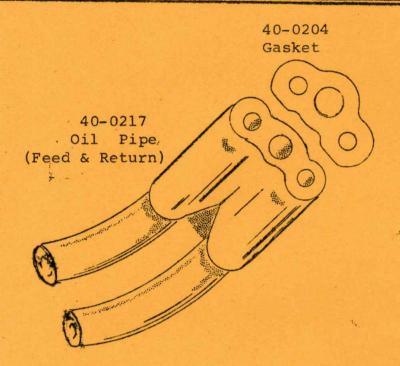
IT IS IMPORTANT THAT THE FITTING OF OIL PIPE UNION (Feed and return line assembly) GASKET NO. 40-0204 BE CHECKED ON EASH ASSEMBLY TO BE SURE THE GASKET HAS NOT BEEN RE-VERSED.

GASKET NO. 40-0204 IS NOT A "MIRROR" GASKET (i.e. it is not the same if reversed).
INSTALLING IT UPSIDE DOWN WILL RESULT IN CLOSING OFF HALF OF THE OIL FEED AND OIL RETURN HOLES.

The middle hole for the affixment stud is not exactly in the center with the result that the gasket can be reversed accidentally and will still permit the union being drawn up BUT WITH THE RESULT THAT THE OIL HOLES WILL BE PARTIALLY RESTRICTED TO THE SERIOUS DETRIMENT OF THE OIL FLOW AND CAPACITY.

Field experience indicates that this has happened in a number of instances of assembly either through "rushed work" or the mechanic not being aware that this gasket can be installed backwards. Big end failure can result from such assembly.

The fitting is easily accessible on the B40SS90 models and access can be gained on the C15SR Roadster and C15S Scrambler by removing the engine skid plate. It is recommended that this inspection be performed on all salesfloor models as well as on all such models coming into your shops for service.
