## DEALER PARTS and SERVICE BULLETIN

NO. 71  
10 MARCH 1962

SPECIAL VALVE SPRING INSTALLATION

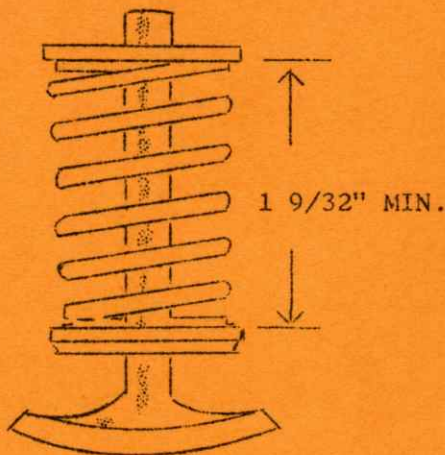
Cases of damage to the valve actuating mechanism have been reported where the valve springs have been incorrectly "packed" to increase valve spring pressure in high performance engines. This sometimes occurs when special S&W racing valve springs are incorrectly installed, leading to galled camshafts or tappets and the belief that these components were "soft" or that the spring pressure was excessive whereas, in reality, the sole cause is incorrect assembly which left the valve springs coil-bound.

"Coil-binding" simply means that the lower valve collar has had some form of "washering" to raise it and thus compress the spring to maximum limits for maximum pressure in a high-revving engine. Carelessly done this often results in over-compressing the spring to a point where - when the valve is fully open - the coils close up and touch. When this occurs there can be no more compression - something has to give. If it is a slight closure - a few thousandths more than it should be - either the push rod has to bend, or the tappet has to bear down on the camshaft. This immediately destroys the hard-surfacing on the camshaft, grinding away the top of the lobe and galling the tappet. As soon as the tappet galls the rough surface grinds away the remainder of the camshaft. None of this has any bearing on the quality of the valve spring or valve gear - only on the quality of the workmanship of the mechanic. For a starting point it is recommended that a minimum spacing of  $1 \frac{9}{32}$ " (as per sketch) be employed between the upper and lower valve spring collars with the valve spring in position, fully closed.

THEN - WITH THE VALVE FULLY OPEN TO MAXIMUM CAM LIFT IT IS ESSENTIAL THAT THERE SHOULD BE AT LEAST SUFFICIENT ADDITIONAL CLEARANCE TO TAKE ABOUT TWO FULL TURNS ON THE TAPPET ADJUSTING SCREW BEFORE THE COILS CLOSE UP. IN THE CASE OF GOLD STAR MODELS THERE SHOULD BE SUFFICIENT ADDITIONAL CLEARANCE TO TURN THE ECCENTRIC ADJUSTING SCREW ABOUT .050".
