SERVICE BULLETIN #28-69

May 20, 1969

SUBJECT: Seized Oil Pumps, Models B25-B44.

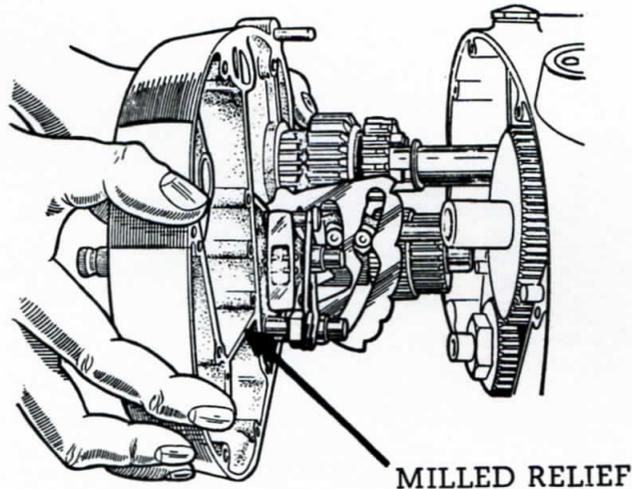
It has been reported by dealers that some B25 oil pumps inspected during engine overhaul have been tight, or actually seized.

This has been due to a fouling condition between the rib on the inner cover and the outer rib on the pump body --causing pressure on the pump body.

The rib on the inner cover should be relieved by milling a 1" x 1/8" relief. A rotary cutter and 1/4" electric drill will do a sufficient job.
