SERVICE SHEET

No 69X

MODEL C15.

CRANKCASE.

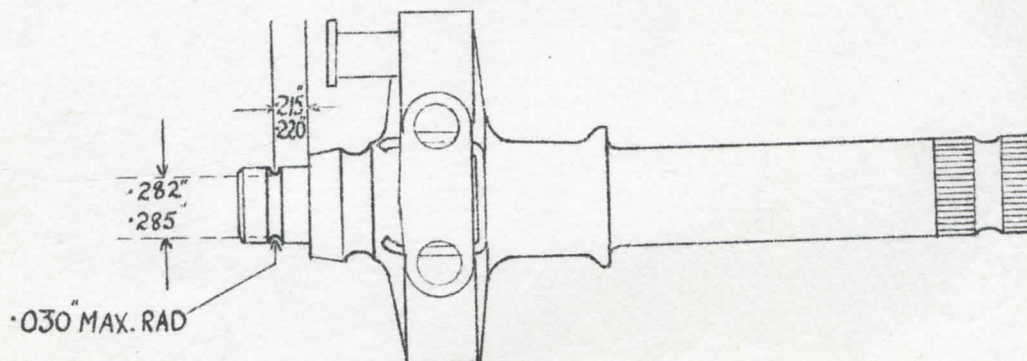
To prevent oil transfer from the gearbox to the crankcase on engines before C15 10329, a gearchange quadrant fitted with an "O" ring seal has been developed. The part number complete is 40-3056.

Engines after C15 10329 have a blind hole in the crankcase wall instead of a through drilling.

Existing quadrants can be modified by turning a groove .030" maximum radius as in the drawing below. The groove must have a fine finish.

Part number of the "O" ring is 76-297.
