No. 24/71

Service sheet

EXHAUST SYSTEM

B50 MX

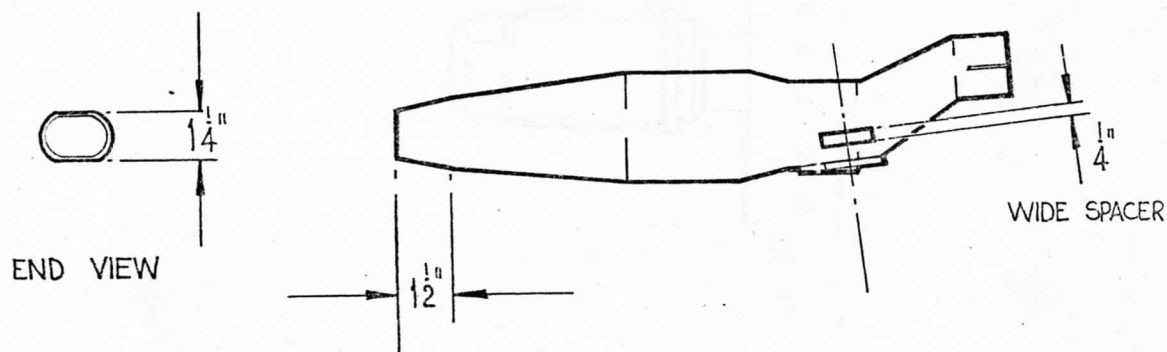
A limited number of the first B50 MX models to be despatched had a condition whereby on full compression of the rear suspension, the megaphone silencer fouled the rear wheel spokes.

Top view of megaphone silencer

To rectify, deform the outlet end of the megaphone cone by compressing in a clamp or vice to make the outlet oval and measure $1\frac{1}{4}$ " across. Secondly, fit a $\frac{1}{4}$ " distance piece between the megaphone bracket and its fixing point on the frame.

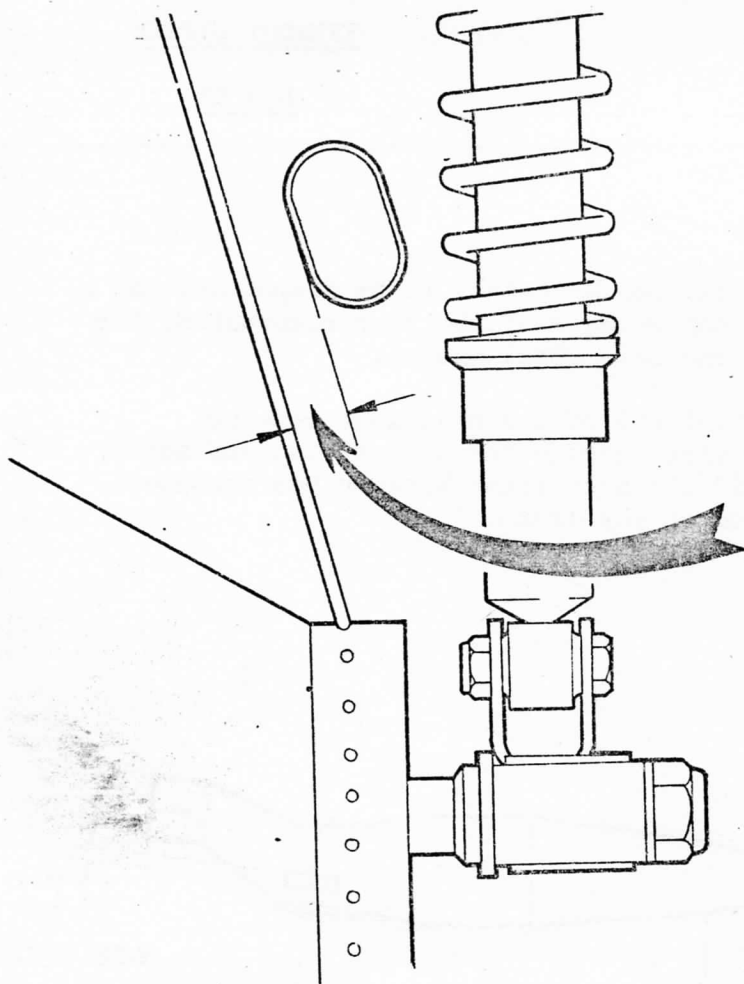
Outlet of megaphone silencer
to be parallel with spokes.
