HINTS AND TIPS ON —SERVICE—

Service Bulletin #165

June 12, 1964

SUBJECT: OVERHEAD ROCKER OIL FEED LINES ON ALL A50 AND A65 MODELS

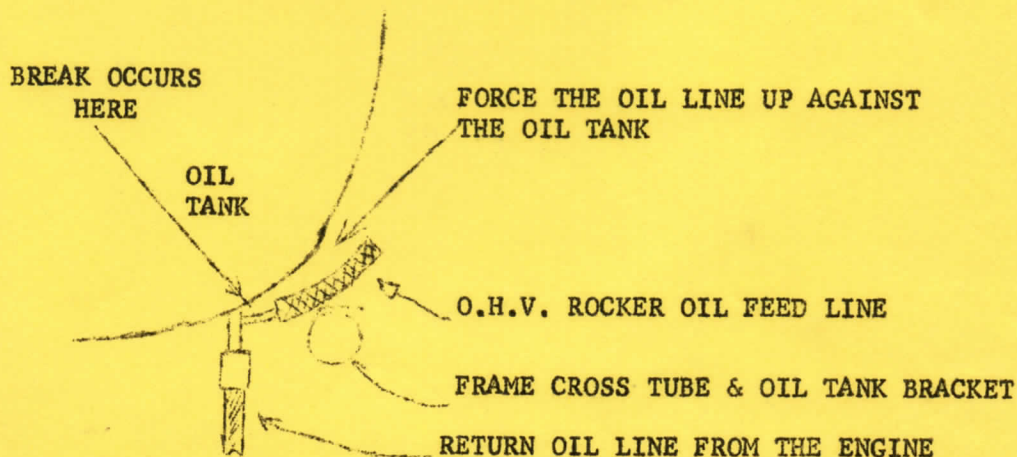
We have received reports that a number of rocker box oil feed lines have broken off at the oil tank fitting.

If this oil feed line to the rocker box is too close to the frame bracket, the movement of the rubber mounted tank is apt to cause it to break.

You must inspect all the machines you have sold and the ones you have on your Showroom Floor and if the rubber connector touches the frame bracket you must force it up close against the oil tank as far away as possible from the frame bracket.
