SERVICE SERIES No. 4

The 1938 "EMPIRE STAR" M.23 B.S.A.

Engine Restoration Routine for a Popular Type of 500 c.c. o.h.v. Machine

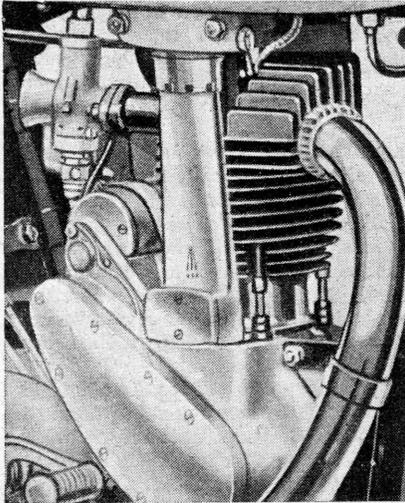
The "Empire Star" B.S.A. engine which is the subject of this article.

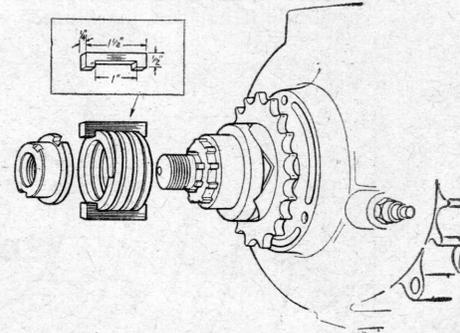
Details of a compressor to aid the fitting of the shock absorber spring on the engine mainshaft.

When installing new main bearings, remember that between the two drive-side journals there is a distance piece. Connecting-rod location and end-float are controlled by the shock absorber, which pulls the two bearings and the distance piece together. Omission of this spacing collar will produce an odd result when the shock absorber is assembled!

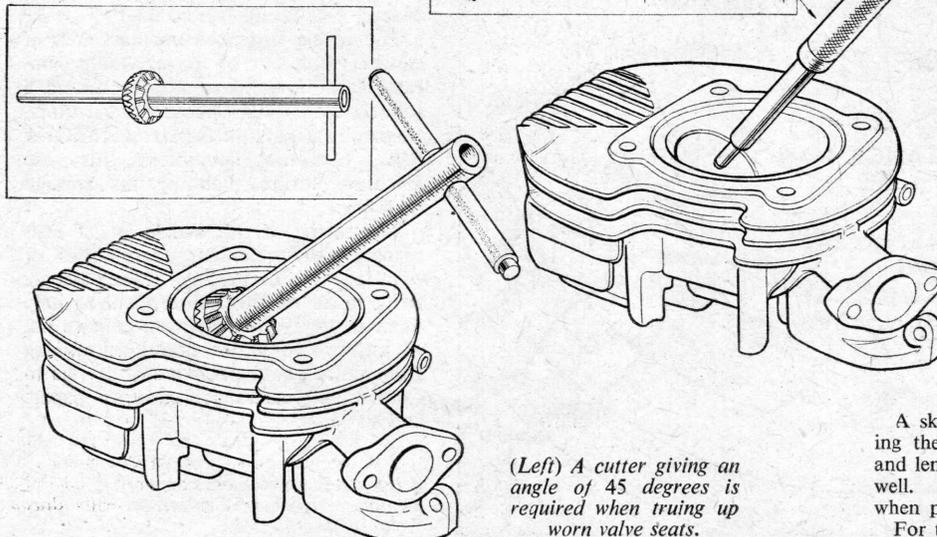
(Left) A cutter giving an angle of 45 degrees is required when truing up worn valve seats.

(Left) Dimensions for a drift for removing worn-out valve guides.

Wear in the cylinder head assembly is likely to be confined to valves, guides and valve springs. All are obtainable from the factory. A suitable drift for removing the valve guides is illustrated, and can easily be made up.

Valve seats should be recut if badly pitted and always if new valve guides are fitted. Most garages have equipment for this job and the cost is small; a seat grinding stone will possibly make a better job of a valve seat than will a blunt cutter. Seat angles for both valves are 45 degrees. Badly pocketed seats will have to be dealt with by cutting back and blending with the head, or by welding. The method will depend on the amount of pocketing. Wear on the exhaust valve lifter mechanism is unknown at the factory so it is unlikely that there will be any reconditioning to do here.

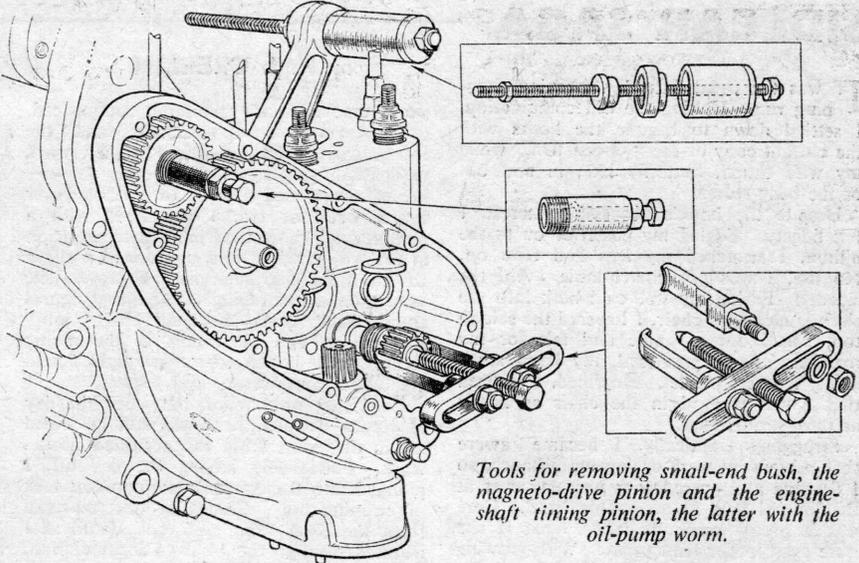
Tools for removing small-end bush, the magneto-drive pinion and the engine-shaft timing pinion, the latter with the oil-pump worm.

Do not mislay the key which locates the engine-shaft pinion, nor forget the tab washer that secures the nut holding this pinion.
