SERVICE BULLETIN NO. 291

SUBJECT: Front brake cable route on "A" Models fitted with double leading shoe brake.

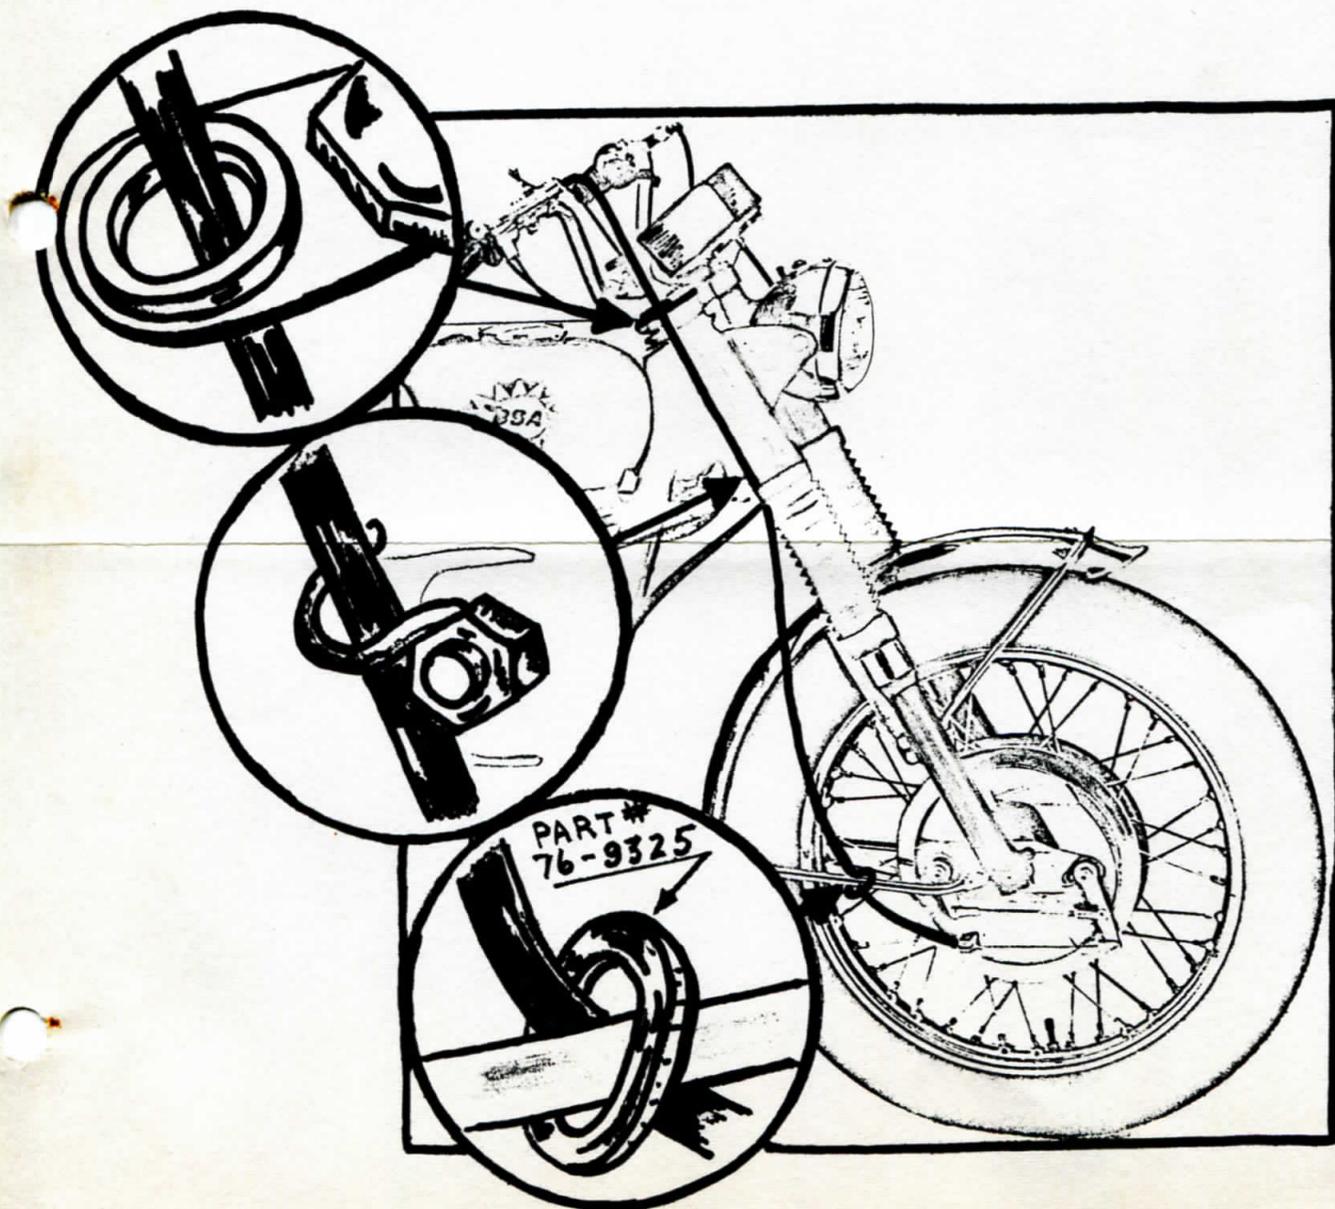
The picture below illustrates the proper route using the three cable guides in which the front brake cable must follow. Rubber grommet, Part #76-9325 is used on the fender brace to keep the cable from drifting.
